**Flood Control Project Maintenance  
Levee Inspections**  
**LMA District Cover Sheet**  
**Spring 2017 Levee Inspection Results**

**Reclamation District No. 2058 Pescadero**

## Levee Inspection Report By Mile - Spring 2017

Waterway	Bank	Unit Miles	Inspection Start/End	Inspector
Unit No. 01 Paradise Cut	Left	6.58	04/19/2017 04/19/2017	Maksim Khashchuk

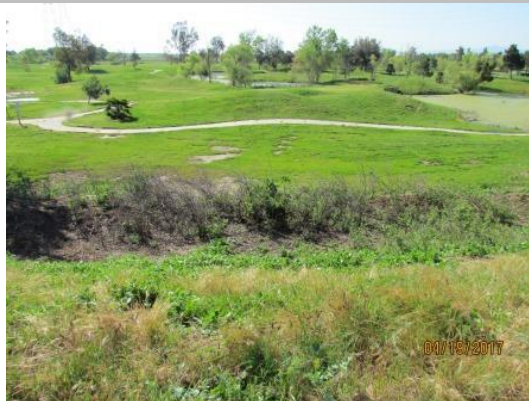
Photo 1 of 1 : SP\_2017\_RD2058\_111\_4\_20170421\_00042.jpg

LM Start	0.23	Rating **	M	Issue No.	4
LM End	0.23	Issue Type +	Ma	Location *	LS
Category	Earthen Levee			GPS Latitude/Longitude	
				Start	End
Item	Vegetation			37.804351 °	37.804351 °
				-121.418433 °	-121.418433 °
DWR ID	DWR_RD2058_01_f_2013_4				
Comment Code					
V2 : Remove the wild growth other than native grasses from the levee slopes.					
Inspector Comment					
Wild rose on the levee. This area is riparian rabbit habitat.

View of the wild rose on the levee slope obstructing visibility and access.

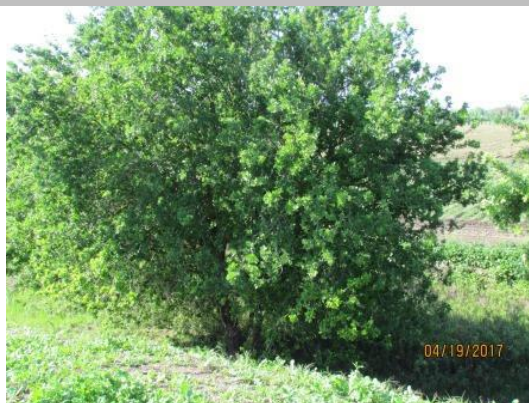
Photo 1 of 1 : SP\_2017\_RD2058\_111\_21\_20170421\_00043.jpg

LM Start	0.55	Rating **	M	Issue No.	21
LM End	0.55	Issue Type +	Ma	Location *	LS
Category	Earthen Levee			GPS Latitude/Longitude	
				Start	End
Item	Trim / Thin Trees			37.802369 °	37.802369 °
				-121.413902 °	-121.413902 °
DWR ID	DWR_RD2058_01_s_2017_21				
Comment Code					
T1 : Trim trees to at least five feet above ground level.					
Inspector Comment

View of the tree that needs to be trimmed.

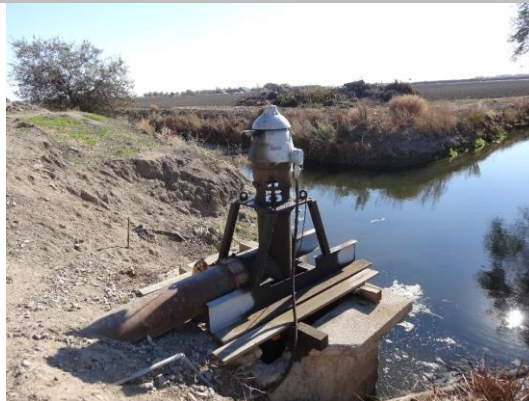
Photo 1 of 3 : UCIP\_SP\_2017\_45843\_45165.jpg

LM Start	0.72	Rating **	M	Issue No.	975
LM End	0.72	Issue Type +	En	Location *	LS
Category	Supplemental			GPS Latitude/Longitude	
				Start	End
Item	DWR UCIP Field Study			37.801792 °	37.801792 °
				-121.410921 °	-121.410921 °
DWR ID					
Comment Code					
Inspector Comment					
FS_ID:45843 DS_ID:22700 EP_NO: 5055 Repair Type: Non-Urgent Crossing Status: Found UCIP Comments: Excessive oil leakage. FIELD_STRUCT_DESC: 16-inch steel stormdrain pipe through levee 3.8 feet below crown. Pump on concrete sump on landside. Siphon breaker under protective cover on the waterward slope (Permit No. 5055, 1666). FS Date: 5/12/2015

LS view: exposed pipe and vertical pump on concrete sump on drain ditch.

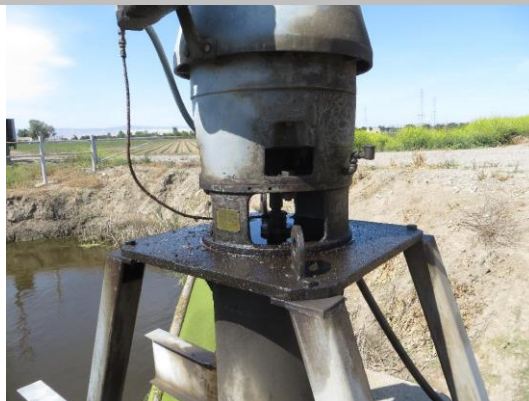
Photo 2 of 3 : UCIP\_SP\_2017\_45843\_74061.jpg

LS view: closeup of pump showing excessive oil leakage.

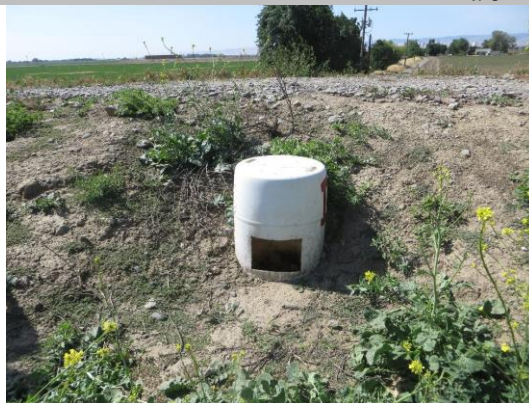
Photo 3 of 3 : UCIP\_SP\_2017\_45843\_74060.jpg

LM Start	0.72	Rating **	M	Issue No.	975 (cont)	
LM End	0.72	Issue Type +	En	Location *	LS	
Category	Supplemental			GPS Latitude/Longitude		
				Start	End	
Item	DWR UCIP Field Study			37.801792 °	37.801792 °	
				-121.410921 °	-121.410921 °	
DWR ID						
Comment Code						
Inspector Comment						
FS_ID:45843						
DS_ID:22700						
EP_NO: 5055						
Repair Type: Non-Urgent						
Crossing Status: Found						
UCIP Comments: Excessive oil leakage.						
FIELD_STRUCT_DESC: 16-inch steel stormdrain pipe through levee						
3.8 feet below crown. Pump on concrete sump on landside. Siphon						
breaker under protective cover on the waterward slope (Permit No.						
5055, 1666).						
FS Date: 5/12/2015

WS view: siphon breaker in protective casing.

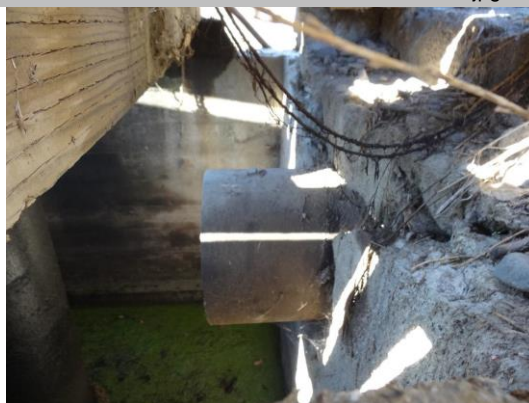
Photo 1 of 1 : UCIP\_SP\_2017\_45143\_45168.jpg

LM Start	0.72	Rating **	A/W	Issue No.	976
LM End	0.72	Issue Type +	Ma	Location *	LS
Category	Supplemental			GPS Latitude/Longitude	
				Start	End
Item	DWR UCIP LMA Responsibility			37.801792 °	37.801792 °
				-121.410921 °	-121.410921 °
DWR ID					
Comment Code					
Inspector Comment					
FS_ID:45143					
DS_ID:22704					
EP_NO: N/A					
Repair Type: No Action Needed					
Crossing Status: Found					
UCIP Comments:					
FIELD_STRUCT_DESC: *Abandoned* 12-inch pipe 18.0 feet below crown. Flap gate on waterward side. Pump on landward side. Grouted in place under Permit No. 5055. Originally included in the 1964 O&M manual, SJR 10, March 1964.					
FS Date: 5/12/2015

LS view: an abandoned pipe found in concrete sump.

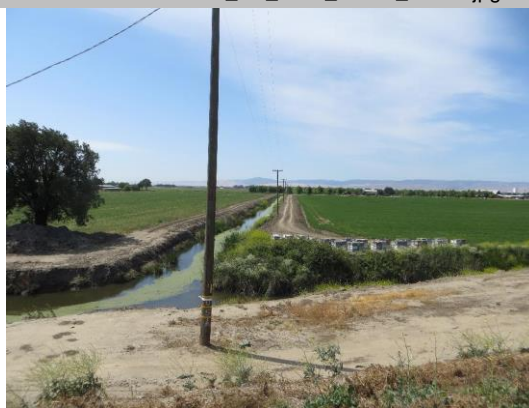
Photo 1 of 1 : UCIP\_SP\_2017\_45847\_74322.jpg

LM Start	1.21	Rating **	M	Issue No.	977
LM End	1.21	Issue Type +	En	Location *	LS
Category	Supplemental			GPS Latitude/Longitude	
				Start	End
Item	DWR UCIP Field Study			37.802249 °	37.802249 °
				-121.402183 °	-121.402183 °
DWR ID					
Comment Code					
Inspector Comment					
FS_ID:45847 DS_ID:22693 EP_NO: 10426 Repair Type: Non-Urgent Crossing Status: Indicator Found UCIP Comments: Crossing needs to be marked. FIELD_STRUCT_DESC: 33-inch steel sewer pipe through levee 17.0 feet below crown. Manholes visible along Delta Ave but no other indicators visible at levee (Permit No. 10426, 1975). FS Date: 5/12/2015

View of LS. Alignment of Crossing to right of canal at dirt access road.

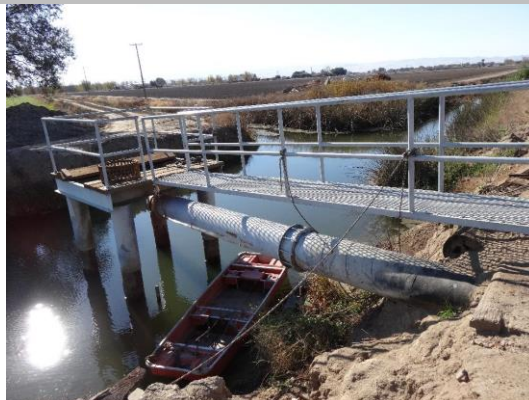
Photo 2 of 3 : UCIP\_SP\_2017\_51161\_45170.jpg

FS\_ID:51161  
DS\_ID:22694  
EP\_NO: 11546  
Repair Type: Urgent  
Crossing Status: Found  
UCIP Comments: 11/29/2016 Heavy erosion still present. Could be due to wave run-up as this is the only spot on levee not rock revetted. Greg Pombo (RD2058) indicated permits for endangered species prevent rock revetment. (K. Fazel - UCIP)05/12/2015 Erosion on west side of pipe at W/S toe. (K. Fazel - UCIP)  
FIELD\_STRUCT\_DESC: 18-inch steel drainage pipe through the levee, 2 feet below the crown. Pump in ditch on the landside (LS). Siphon breaker with cover on waterside (WS) shoulder. Electrical service pole at the LS toe. (Permit No. 11546, 1976 - Reclamation District 2058).  
FS Date: 11/29/2016

LS view: pipe, pile structure, and pump platform in drain ditch.

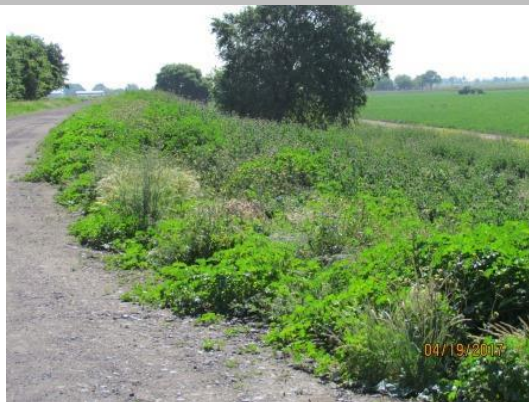
Photo 1 of 1 : SP\_2017\_RD2058\_111\_24\_20170421\_00044.jpg

LM Start	1.24	Rating **	M	Issue No.	24
LM End	2.11	Issue Type +	Ma	Location *	LS
Category	Earthen Levee			GPS Latitude/Longitude	
				Start	End
Item	Vegetation			37.802341 °	37.803914 °
				-121.401752 °	-121.386402 °
DWR ID	DWR_RD2058_01_s_2017_24				
Comment Code					
V1 : Control annual grass and weeds on the levee slopes and easements.					
Inspector Comment

View of the vegetation on the levee slope.

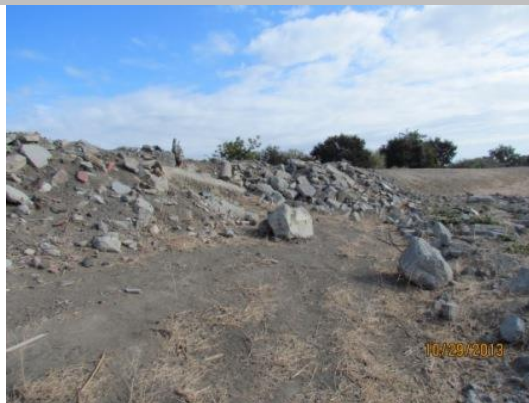
Photo 1 of 1 : SP\_2017\_RD2058\_111\_11\_20170407\_00005.jpg

View of the concrete with rebar placed on the landside slope.

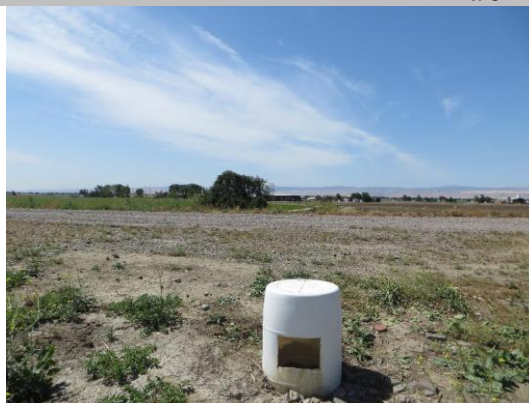
Photo 1 of 3 : UCIP\_SP\_2017\_45865\_74323.jpg

LM Start	2.12	Rating **	A/W	Issue No.	979
LM End	2.12	Issue Type +	Ma	Location *	LS
Category	Supplemental			GPS Latitude/Longitude	
				Start	End
Item	DWR UCIP LMA Responsibility			37.803892 °	37.803892 °
				-121.386299 °	-121.386299 °
DWR ID					
Comment Code					
Inspector Comment					
FS_ID:45865 DS_ID:22705 EP_NO: N/A Repair Type: No Action Needed Crossing Status: Found UCIP Comments: FIELD_STRUCT_DESC: 20-inch steel stormdrain pipe 8.0 feet below crown. Siphon breaker on waterside. Pump on concrete sump in drain ditch on LS toe. Originally included in the 1964 O&M manual, SJR 10, March 1964. FS Date: 5/12/2015

Siphon breaker on WS shoulder inside protective riser.

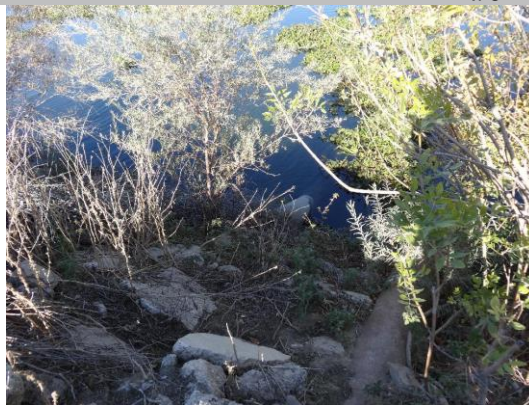
Photo 2 of 3 : UCIP\_SP\_2017\_45865\_74324.jpg

LM Start	2.12	Rating **	A/W	Issue No.	979 (cont)	
LM End	2.12	Issue Type +	Ma	Location *	LS	
Category	Supplemental			GPS Latitude/Longitude		
				Start	End	
Item	DWR UCIP LMA Responsibility			37.803892 °	37.803892 °	
				-121.386299 °	-121.386299 °	
DWR ID						
Comment Code						
Inspector Comment						
FS_ID:45865 DS_ID:22705 EP_NO: N/A Repair Type: No Action Needed Crossing Status: Found UCIP Comments: FIELD_STRUCT_DESC: 20-inch steel stormdrain pipe 8.0 feet below crown. Siphon breaker on waterside. Pump on concrete sump in drain ditch on LS toe. Originally included in the 1964 O&M manual, SJR 10, March 1964. FS Date: 5/12/2015

Pipe just visible at WS toe at center of photograph.

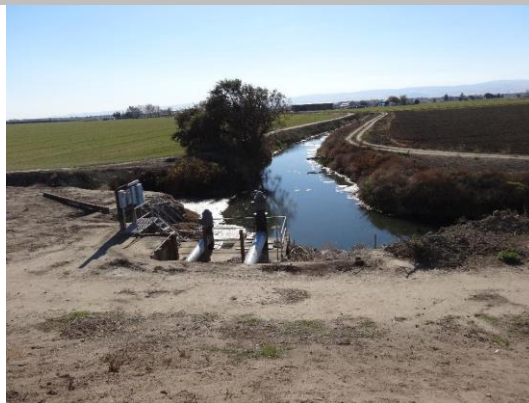
Photo 3 of 3 : UCIP\_SP\_2017\_45865\_74325.jpg

Pump on concrete pad at LS toe.

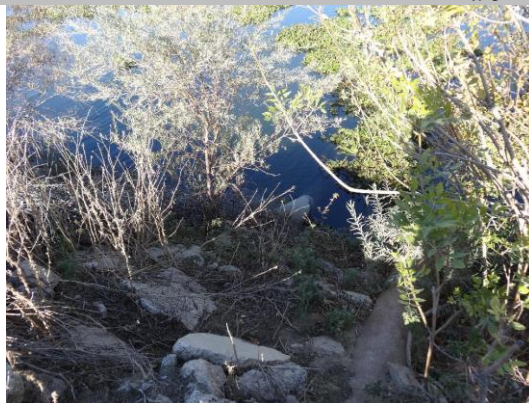
Photo 1 of 3 : UCIP\_SP\_2017\_51699\_45192.jpg

LM Start	2.12	Rating **	M	Issue No.	980
LM End	2.12	Issue Type +	Ma	Location *	LS
Category	Supplemental			GPS Latitude/Longitude	
				Start	End
Item	DWR UCIP LMA Responsibility			37.803886 °	37.803886 °
				-121.386271 °	-121.386271 °
DWR ID					
Comment Code					
Inspector Comment					
FS_ID:51699					
DS_ID:22706					
EP_NO: N/A					
Repair Type: Non-Urgent					
Crossing Status: Found					
UCIP Comments: Leaky and damaged siphon breaker on waterside shoulder..					
FIELD_STRUCT_DESC: 16-inch steel stormdrain pipe 8.0-feet below the crown. Siphon Breaker on waterward shoulder. Pump on concrete sump on landside. Originally included in the 1964 O&M manual, SJR 10, March 1964.					
FS Date: 5/13/2015

WS view: exposed steel pipe (right) on channel bank.

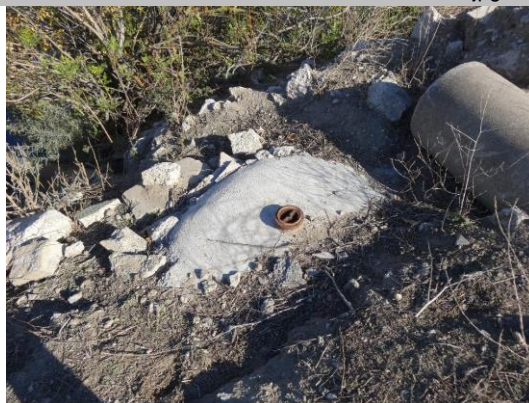
Photo 2 of 3 : UCIP\_SP\_2017\_51699\_45191.jpg

WS view: siphon breaker on concrete pad on levee slope.

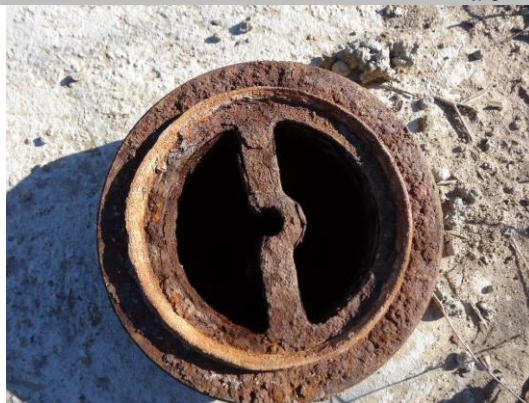
Photo 3 of 3 : UCIP\_SP\_2017\_51699\_45190.jpg

LM Start	2.12	Rating **	M	Issue No.	980 (cont)
LM End	2.12	Issue Type +	Ma	Location *	LS
Category	Supplemental			GPS Latitude/Longitude	
				Start	End
Item	DWR UCIP LMA Responsibility			37.803886 °	37.803886 °
				-121.386271 °	-121.386271 °
DWR ID					
Comment Code					
Inspector Comment					
FS_ID:51699					
DS_ID:22706					
EP_NO: N/A					
Repair Type: Non-Urgent					
Crossing Status: Found					
UCIP Comments: Leaky and damaged siphon breaker on waterside shoulder..					
FIELD_STRUCT_DESC: 16-inch steel stormdrain pipe 8.0-feet below the crown. Siphon Breaker on waterward shoulder. Pump on concrete sump on landside. Originally included in the 1964 O&M manual, SJR 10, March 1964.					
FS Date: 5/13/2015

WS view: Upper part of the siphon breaker missing.

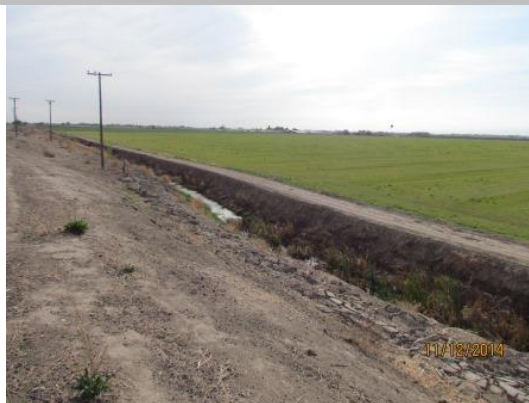
Photo 1 of 1 : SP\_2017\_RD2058\_111\_12\_20170407\_00006.jpg

LM Start	2.24	Rating **	M	Issue No.	12
LM End	2.30	Issue Type +	En	Location *	LS
Category	Earthen Levee			GPS Latitude/Longitude	
				Start	End
Item	Encroachments			37.803375 °	37.803136 °
				-121.384196 °	-121.383078 °
DWR ID	DWR_RD2058_01_f_2013_12				
Comment Code					
DT : Ditch					
Inspector Comment

View of the ditch at the landside levee toe.

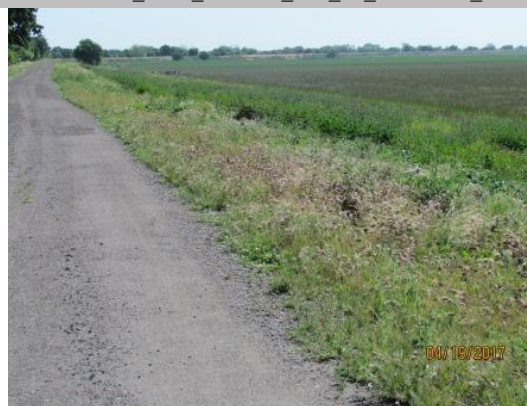
Photo 1 of 1 : SP\_2017\_RD2058\_111\_31\_20170421\_00045.jpg

View of the vegetation on the levee slope.

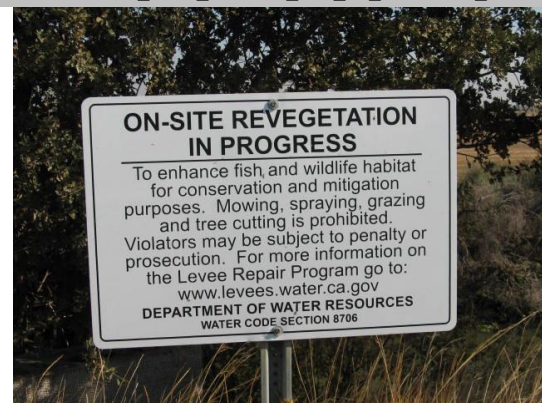
Photo 1 of 1 : SP\_2017\_RD2058\_111\_20\_20170407\_00009.jpg

11/08/2011 Revegetation site, cannot trim or cut vegetation in this area.

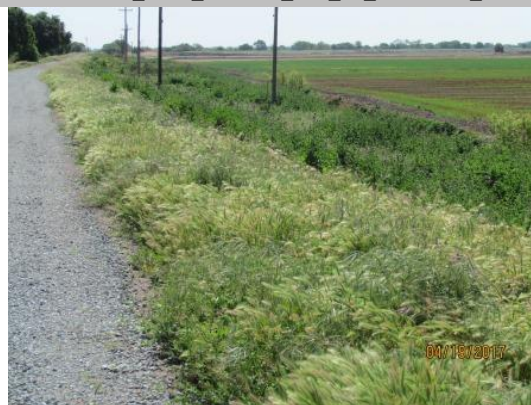
Photo 1 of 1 : SP\_2017\_RD2058\_111\_32\_20170421\_00046.jpg

View of the vegetation on the levee slope.

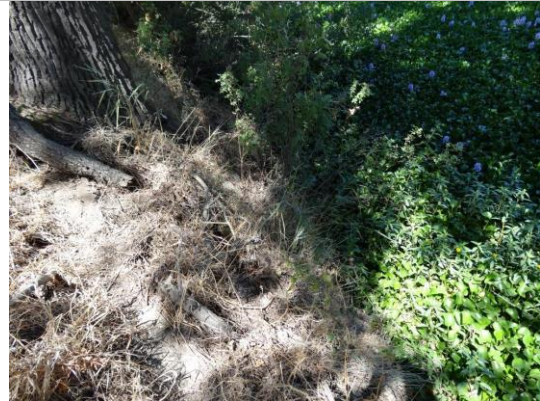
Photo 2 of 3 : SP\_2017\_RD2058\_111\_1\_20170407\_00002.jpg

Comment Code					
Inspector Comment					
07/20/2016: No significant change observed.					
08/04/2015: No significant change observed.					
08/26/2014: No significant change observed.					
08/28/2013: No significant change observed.					
07/26/2012: The site has been visited, and no significant change has been observed.					
09/02/2011: This site was not visited due to the time limit.					
09/22/2010: No significant change observed. Minor pocket erosions are lined at the lower bank. Two large Oak and Willow trees are on mid-slope and bench. The remaining bench was re-measured and found to be approximately 10 feet. There was no indication of active erosion on site during the site visit.					
08/05/2010: Recommended for annual assessment and monitoring of the site during flood events, per CLRO.					
07/23/2009: No major change observed since last visit; site is a 200-ft. long near-vertical berm erosion; recommend annual assessment and monitoring of the erosion site, per CLRO CES Evaluation 2008 Report; Site # is the same site previously reported as RM4.0,LM4.51; previously rated "U".

Direct view of the erosion near a tree. Note the dense vegetation.

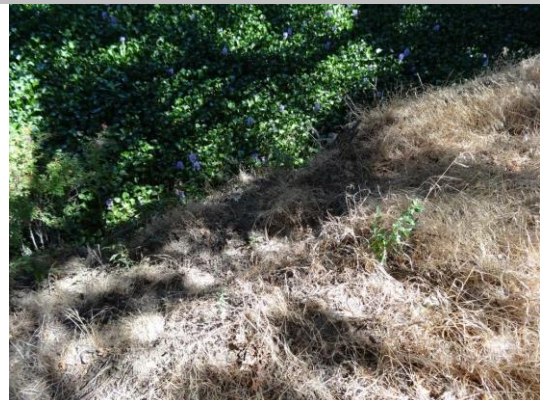
Photo 3 of 3 : SP\_2017\_RD2058\_111\_1\_20170407\_00003.jpg

Direct view of the erosion near a tree.

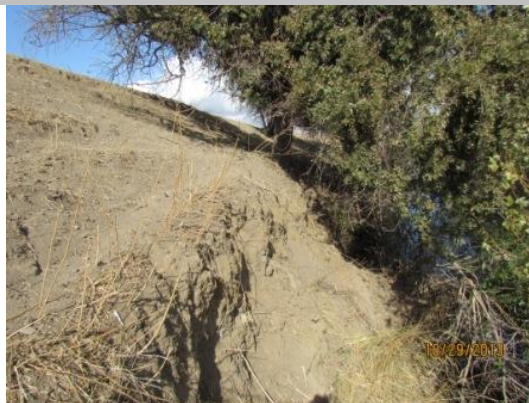
Photo 1 of 1 : SP\_2017\_RD2058\_111\_15\_20170407\_00007.jpg

View of the erosion at the waterside levee toe.

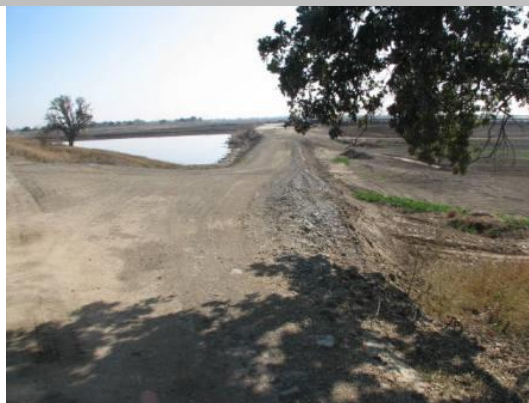
Photo 1 of 3 : SP\_2017\_RD2058\_111\_29\_20170407\_00013.jpg

LM Start	5.10	Rating **	U	Issue No.	29
LM End	5.10	Issue Type +	En	Location *	LS
Category	Earthen Levee			GPS Latitude/Longitude	
				Start	End
Item	Encroachments			37.783102 °	37.783102 °
				-121.345682 °	-121.345682 °
DWR ID	DWR_RD2058_01_s_2012_29				
Comment Code					
RA : Ramp					
Inspector Comment					
New ramp construction connecting dairy to levee. Construction of ramp results in a new pond on the landside of the levee. 2/21/2012, owner has said that he will contact the CVFPB to resolve this issue.

11/08/2011 New ramp has been constructed by Dairy farmer connecting his barns to the levee.

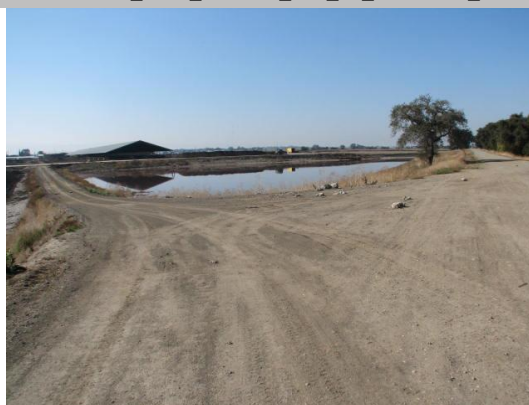
Photo 1 of 3 : SP\_2017\_RD2058\_111\_30\_20170407\_00016.jpg

LM Start	5.29	Rating **	U	Issue No.	30
LM End	5.29	Issue Type +	En	Location *	LS
Category	Earthen Levee			GPS Latitude/Longitude	
				Start	End
Item	Encroachments			37.782268 °	37.782268 °
				-121.342257 °	-121.342257 °
DWR ID	DWR_RD2058_01_s_2012_30				
Comment Code					
RA : Ramp					
Inspector Comment					
Ramp constructed to dairy. Raised ramps, see issue 29 are creating new holding ponds for dairy at levee toe.

11/08/2011 Photo shows existing middle ramp to the levee which has been raised.

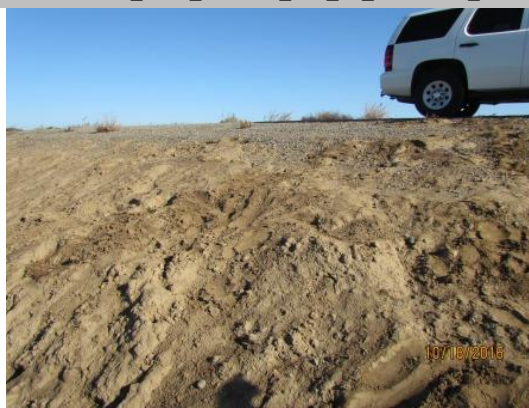
Photo 1 of 1 : SP\_2017\_RD2058\_111\_28\_20170407\_00012.jpg

View of the rodent holes on the levee slope.

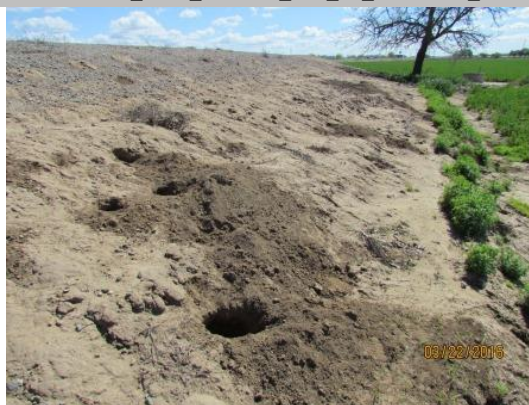
Photo 1 of 1 : SP\_2017\_RD2058\_111\_27\_20170407\_00011.jpg

View of the rodent burrows on the landside levee slope.

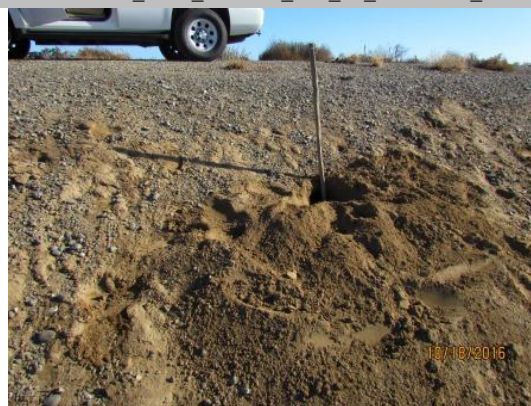
Photo 1 of 1 : SP\_2017\_RD2058\_111\_23\_20170407\_00010.jpg

View of the rodent hole on the landside levee slope.

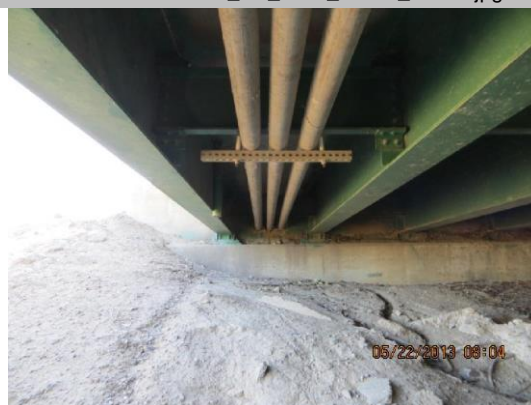
Photo 1 of 3 : UCIP\_SP\_2017\_45871\_73100.jpg

LM Start	6.46	Rating **	M	Issue No.	981
LM End	6.46	Issue Type +	En	Location *	LS
Category	Supplemental			GPS Latitude/Longitude	
				Start	End
Item	DWR UCIP Field Study			37.770158 °	37.770158 °
				-121.329430 °	-121.329430 °
DWR ID					
Comment Code					
Inspector Comment					
FS_ID:45871 DS_ID:22701 EP_NO: 13262 Repair Type: Non-Urgent Crossing Status: Indicator Found UCIP Comments: Owner needs to install signs at crossing. FIELD_STRUCT_DESC: Three 4-inch communication conduits encased in concrete through levee 3.0 feet below crown (Permit No. 13262, 1981). Sign on both banks of levee. Pipes visible under Manthey Rd Bridge at Paradise Cut. FS Date: 5/13/2015

Pipes visible under Manthey Rd Bridge at Paradise Cut.

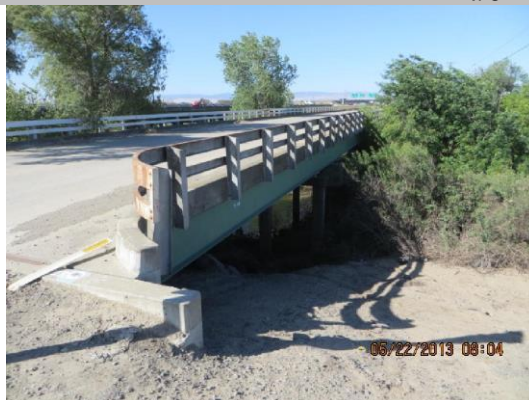
Photo 2 of 3 : UCIP\_SP\_2017\_45871\_73101.jpg

LM Start	6.46	Rating **	M	Issue No.	981 (cont)
LM End	6.46	Issue Type +	En	Location *	LS
Category	Supplemental			GPS Latitude/Longitude	
				Start	End
Item	DWR UCIP Field Study			37.770158 °	37.770158 °
				-121.329430 °	-121.329430 °
DWR ID					
Comment Code					
Inspector Comment					
FS_ID:45871					
DS_ID:22701					
EP_NO: 13262					
Repair Type: Non-Urgent					
Crossing Status: Indicator Found					
UCIP Comments: Owner needs to install signs at crossing.					
FIELD_STRUCT_DESC: Three 4-inch communication conduits					
encased in concrete through levee 3.0 feet below crown (Permit No.					
13262, 1981). Sign on both banks of levee. Pipes visible under					
Manthey Rd Bridge at Paradise Cut.					
FS Date: 5/13/2015

Pipes visible under Manthey Rd Bridge at Paradise Cut.

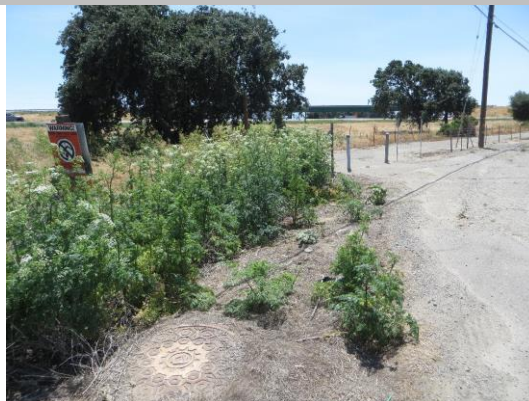
Photo 3 of 3 : UCIP\_SP\_2017\_45871\_74132.jpg

Comm sign and Pac Bell manhole appr. 600 ft from LS toe.

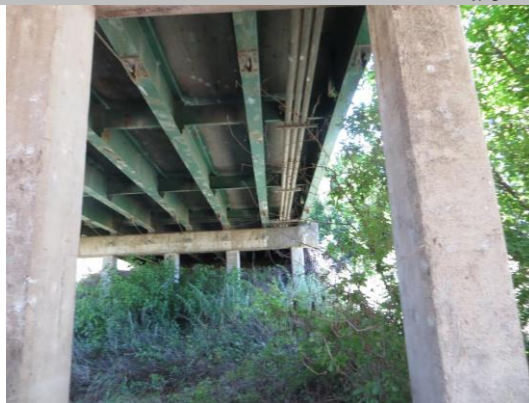
Photo 1 of 3 : UCIP\_SP\_2017\_45768\_74267.jpg

LM Start	6.46	Rating **	M	Issue No.	982
LM End	6.46	Issue Type +	En	Location *	LS
Category	Supplemental			GPS Latitude/Longitude	
				Start	End
Item	DWR UCIP Field Study			37.770159°	37.770159°
				-121.329426°	-121.329426°
DWR ID					
Comment Code					
Inspector Comment					
FS_ID:45768 DS_ID:25077 EP_NO: 13262 Repair Type: Non-Urgent Crossing Status: Indicator Found UCIP Comments: Owner needs to install signs at crossing. FIELD_STRUCT_DESC: 2 of 3: 4-inch communication conduit encased in concrete through levee 3.0 feet below crown. Sign on both banks of levee. Manhole on both sides of Manthey Rd at utility crossing. (Permit No. 13262, 1981) FS Date: 5/13/2015

Pipes visible under Manthey Rd Bridge at Paradise Cut

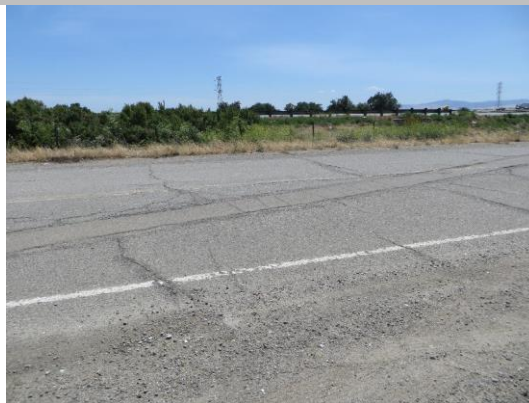
Photo 2 of 3 : UCIP\_SP\_2017\_45768\_74268.jpg

Cuts in pavement visible apprx. 450 ft from WS toe.

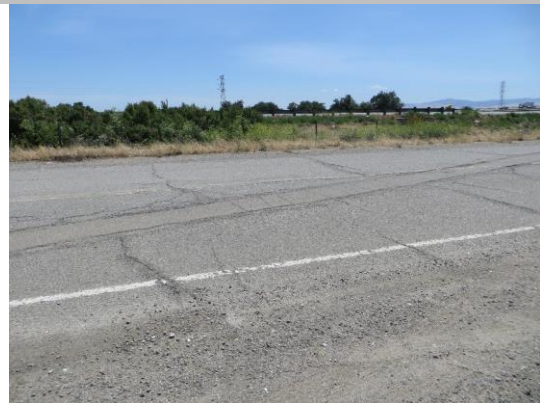
Photo 1 of 3 : UCIP\_SP\_2017\_45769\_74270.jpg

LM Start	6.46	Rating **	M	Issue No.	983
LM End	6.46	Issue Type +	En	Location *	LS
Category	Supplemental			GPS Latitude/Longitude	
				Start	End
Item	DWR UCIP Field Study			37.770158 °	37.770158 °
				-121.329430 °	-121.329430 °
DWR ID					
Comment Code					
Inspector Comment					
FS_ID:45769 DS_ID:25078 EP_NO: 13262 Repair Type: Non-Urgent Crossing Status: Indicator Found UCIP Comments: Owner needs to install sign at crossing. FIELD_STRUCT_DESC: 3 of 3: 4-inch communication conduit encased in concrete through levee 3.0 feet below crown. Sign on both banks of levee. Manhole on both sides of Mantney Rd at utility crossing. (Permit No. 13262, 1981) FS Date: 5/13/2015

Cuts in pavement visible appr. 450 ft from WS toe.

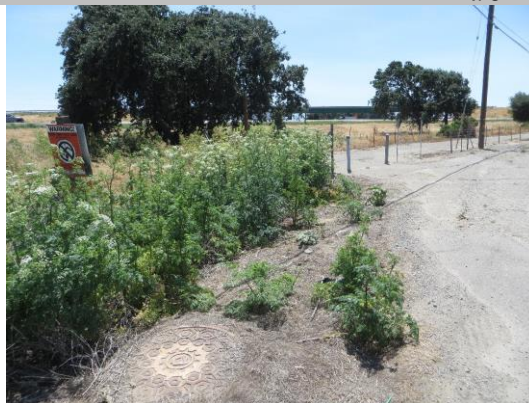
Photo 2 of 3 : UCIP\_SP\_2017\_45769\_74271.jpg

LM Start	6.46	Rating **	M	Issue No.	983 (cont)	
LM End	6.46	Issue Type +	En	Location *	LS	
Category	Supplemental			GPS Latitude/Longitude		
				Start	End	
Item	DWR UCIP Field Study			37.770158 °	37.770158 °	
				-121.329430 °	-121.329430 °	
DWR ID						
Comment Code						
Inspector Comment						
FS_ID:45769						
DS_ID:25078						
EP_NO: 13262						
Repair Type: Non-Urgent						
Crossing Status: Indicator Found						
UCIP Comments: Owner needs to install sign at crossing.						
FIELD_STRUCT_DESC: 3 of 3: 4-inch communication conduit encased						
in concrete through levee 3.0 feet below crown. Sign on both banks of						
levee. Manhole on both sides of Manthey Rd at utility crossing. (Permit						
No. 13262, 1981)						
FS Date: 5/13/2015

Comm sign and Pac Bell manhole appr. 600 ft from LS toe.

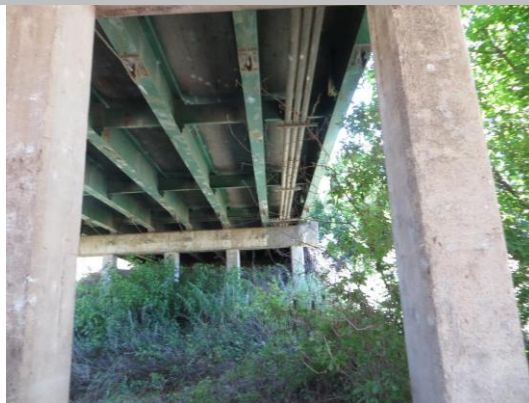
Photo 3 of 3 : UCIP\_SP\_2017\_45769\_74272.jpg

Pipes visible under Manthey Rd Bridge at Paradise Cut.
